ROOM BY ROOM INSPECTION-
HOME (2024)

Panama City Beach, FL 32413

Cornerstone Home Inspections of NW FL, Inc.

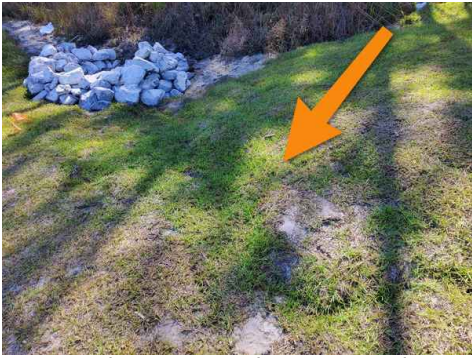
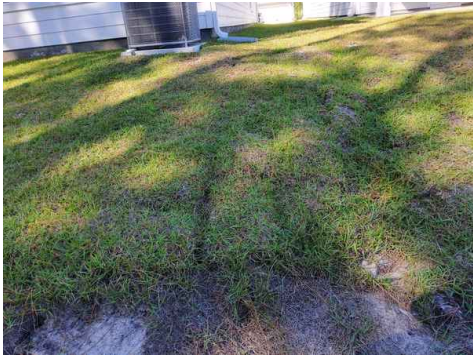
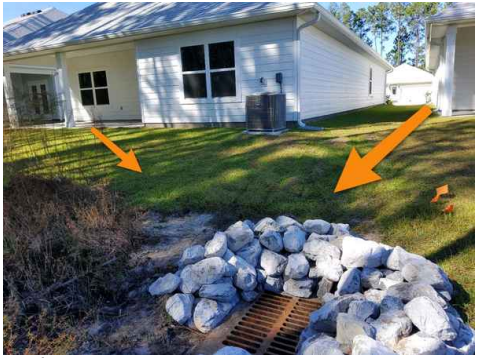
4.1.1 Vegetation, Grading & Drainage

EROSION DUE TO POOR RAIN WATER DRAINAGE

LEFT REAR OF RESIDENCE

Poor drainage can cause erosion around a house, which can lead to significant damage to the foundation. This area of erosion should be addressed with new fill and improved drainage.

Erosion due to poor drainage. Sod needs to be removed and fill placed to correct erosion. Then sod should be replaced.

Soil erosion.

Contact your builder.

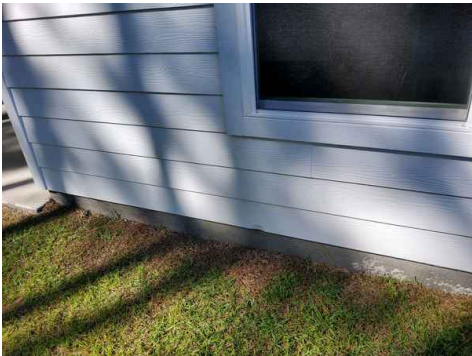
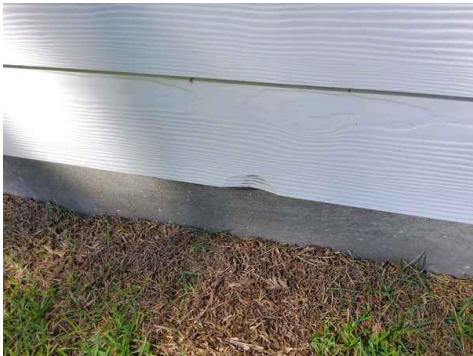
4.3.1 Siding, Flashing & Trim

DAMAGED SIDING

REAR

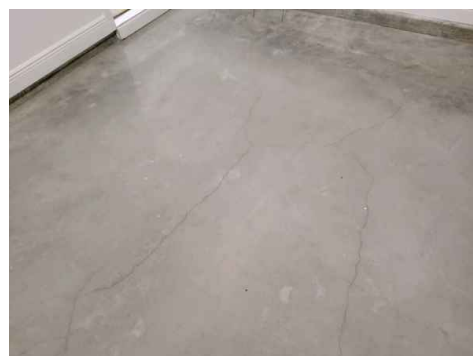
5.5.1 Floor

MINOR CRACKS

Minor hairline cracks in garage floor. These cracks should be monitored.

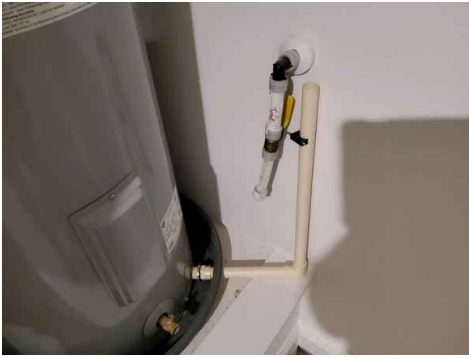
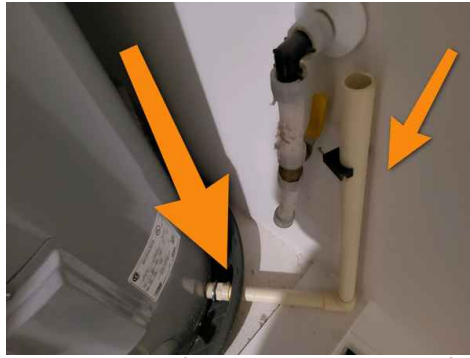
8.1.1 General**HEATER DRAIN PAN NOT PROPERLY PLUMBED**

The drain pan should be plumbed to allow for leaking water to be drained safely.

Drain to water heater pan not properly plumbed.

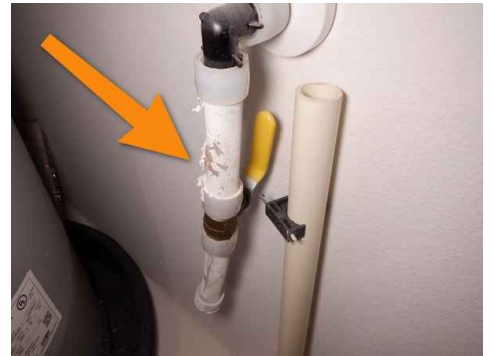
8.1.2 General

UNKNOWN PLUMBING CONNECTION IN GARAGE

The inspector was unable to determine the use of this unknown plumbing connection. Client should inquire of seller of use for this plumbing.

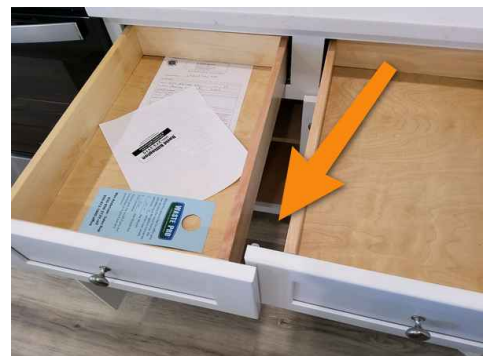
11.2.1 Cabinets

IMPROPER OPENING OF DRAWERS

Two drawers in the kitchen cabinet are not properly installed. When opening the drawers strike each other.

Contact a qualified handyman.

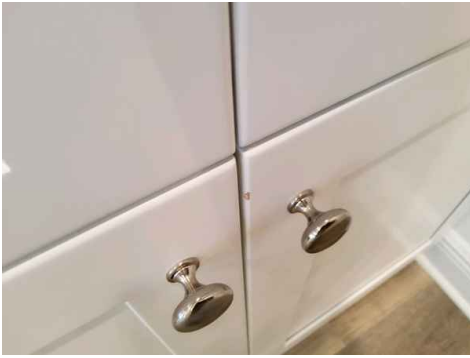
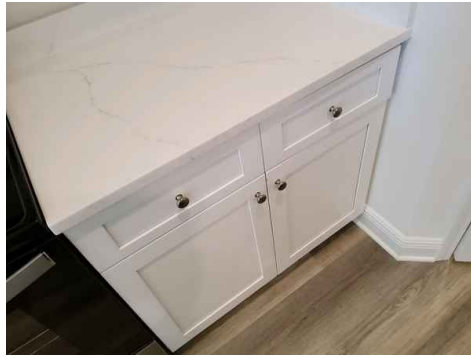
11.2.2 Cabinets

CHIPPED PAINT

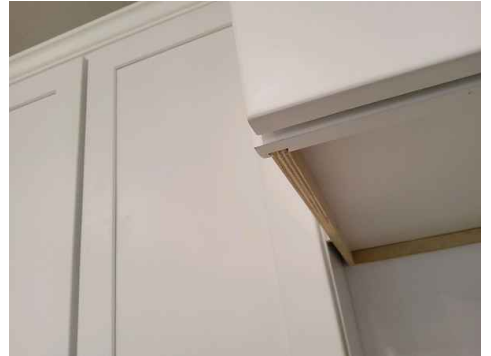
11.2.3 Cabinets

BOTTOM EDGE OF CABINET ABOVE THE REFRIGERATOR IS NOT PAINTED.

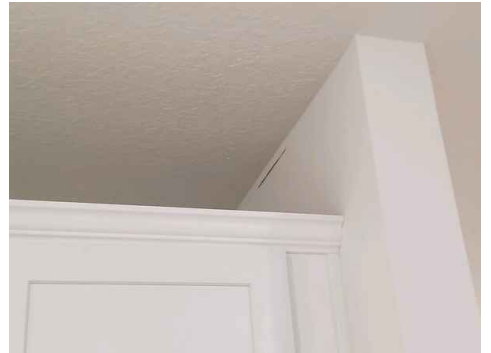
11.8.1 Ceilings

MINOR DAMAGE

Minor damage to the ceiling was visible at the time of the inspection.

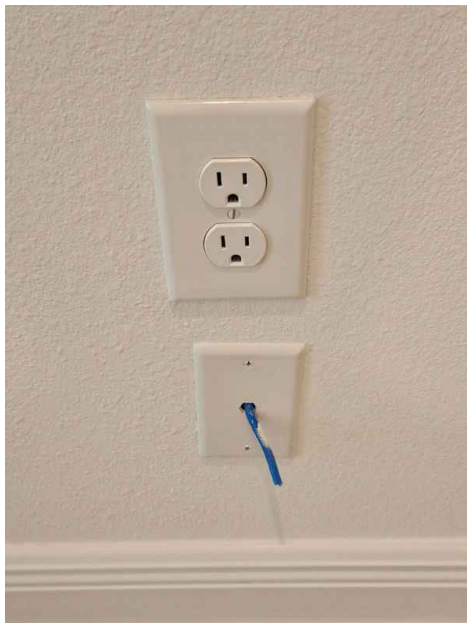
There is no TV cable outlet in the family room but there are in the bedrooms and there appears to be one in the entryway hall of the residence.

This cable outlet is located just inside the front door of the residence in the hallway.

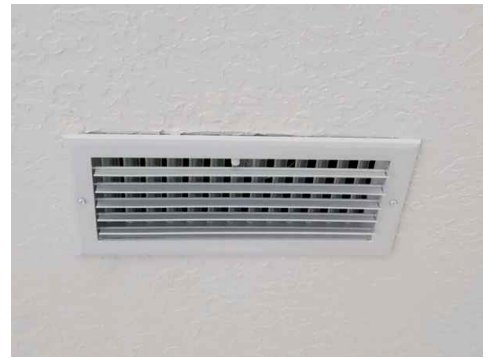
14.5.1 Ceilings

DRYWALL DAMAGE AROUND VENT COVER

Minor damage around the vent cover was visible at the time of the inspection.

Contact a qualified handyman.

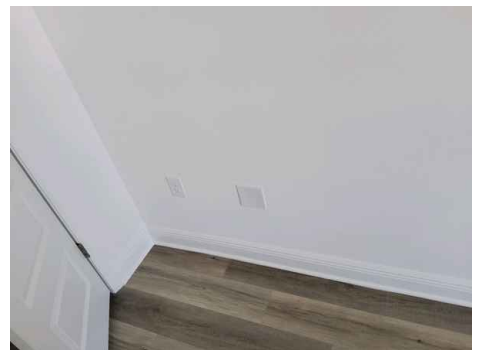
Lighting Fixtures, Switches & Receptacles: Extra junction box- purpose unknown

Extra junction box- purpose
unknown

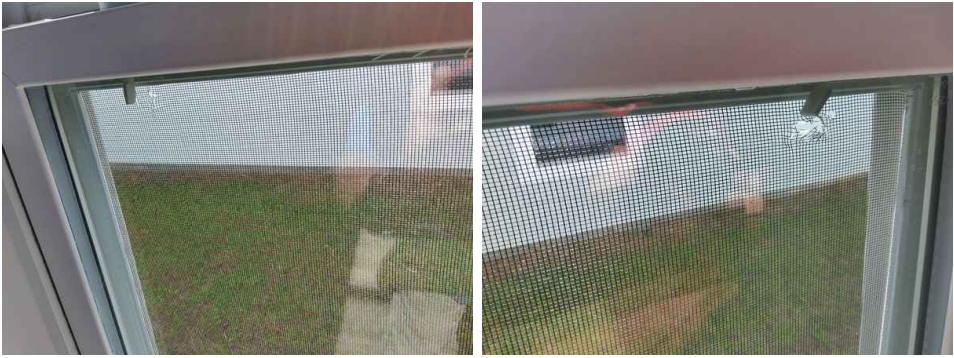
16.3.1 Windows

MISSING OR DAMAGED SCREEN

Window missing screen or screen is damaged.

Recommend replacement.

Contact a qualified window repair/installation contractor.

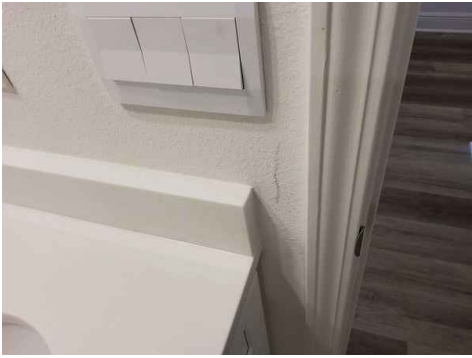
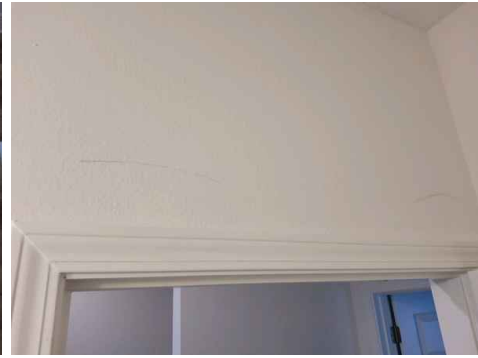
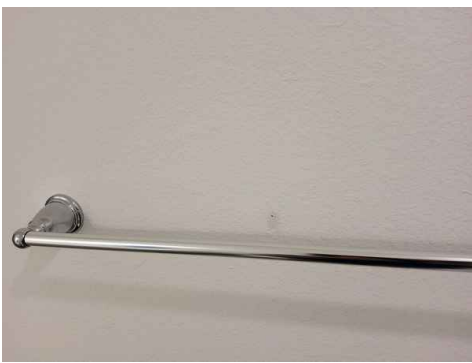
19.8.1 Walls

MARKS ON WALLS

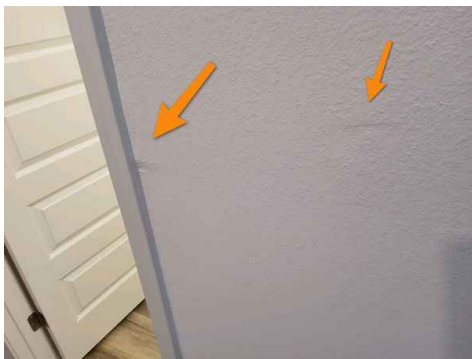
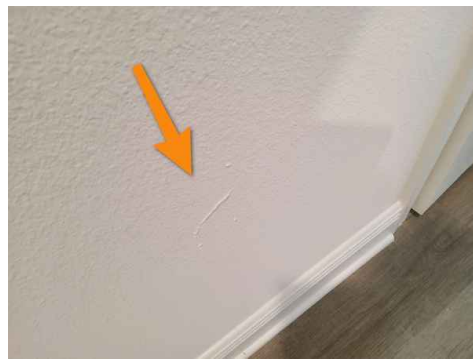
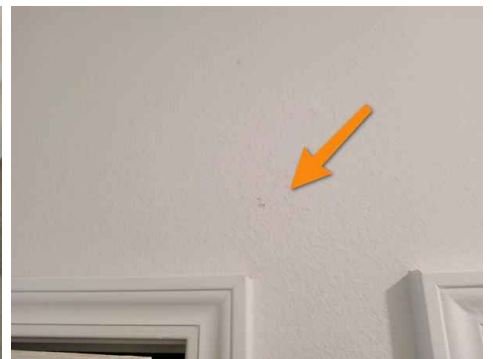
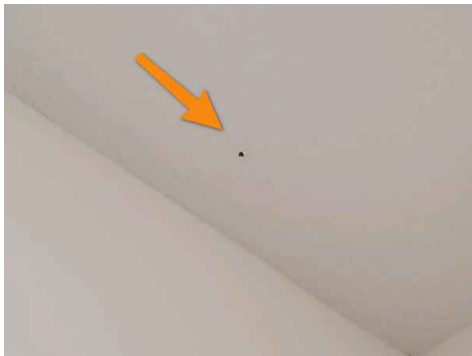
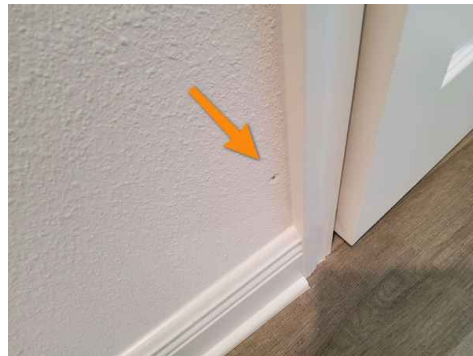
22.1.1 General

DRYWALL DAMAGE

FRONT HALLWAY

There are multiple a drywall/painting damage in the hallway entering the residence and the hall outside bedrooms 2 and 3 around the guest bath entry.

Main entrance hall- ceiling

Outside bedroom door in hall by the guest bath.

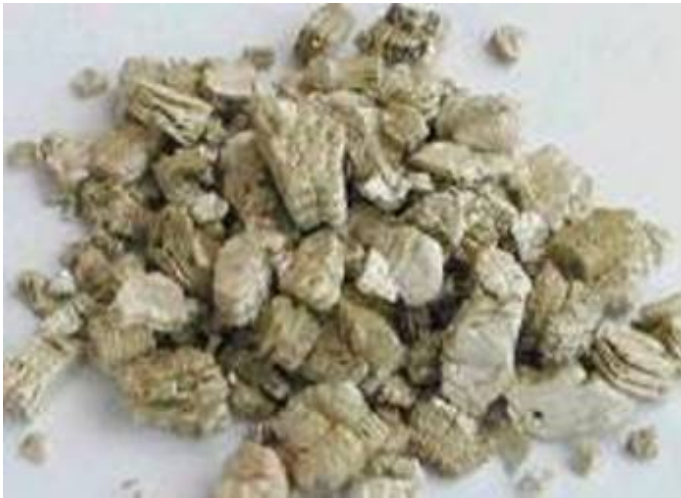
Photo of typical vermiculite insulation. This type of insulation is checked for since vermiculite contains asbestos and should not be disturbed.
